EMEA Aftermarket Press Event  
June 17, 2009

**Insist on Genuine**

### Comparison between a Genuine Garrett® VNT™ Turbo and a Remanufactured VNT™ Turbo

### Comparison between Genuine Garrett® Turbos and Copy/Counterfeit Turbos

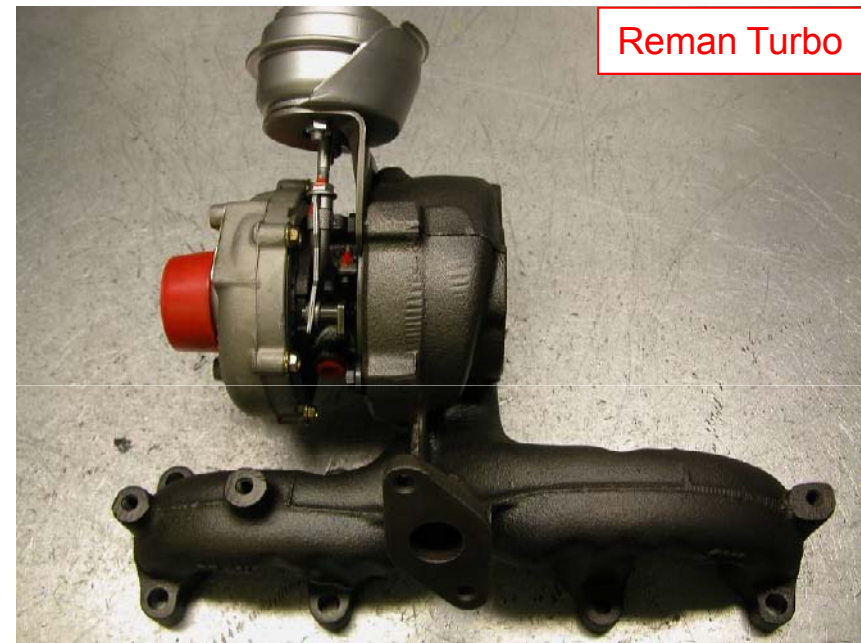
- Typical appearance from used, cleaned housings
- Blast cleaned, re-painted actuator

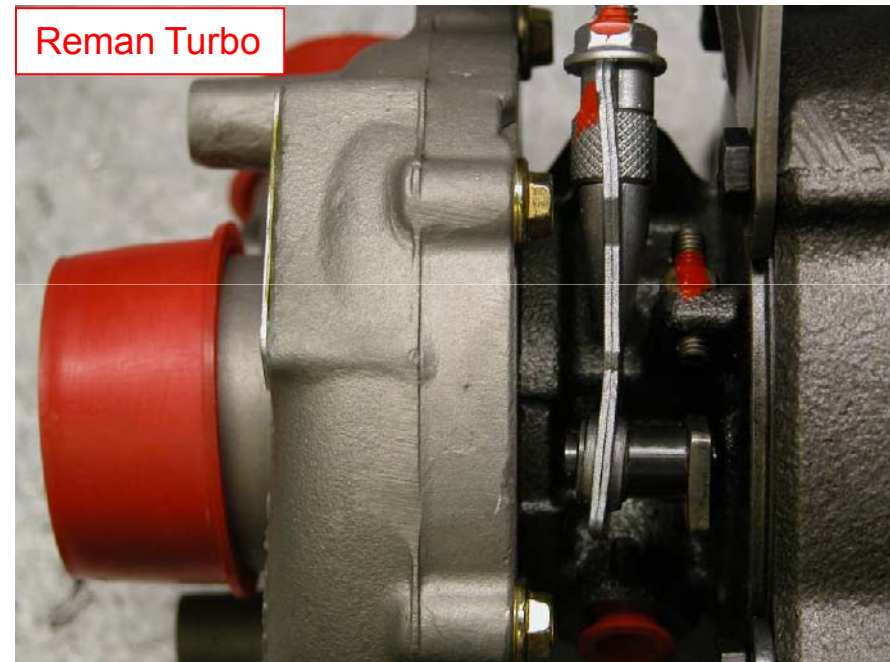
- Twisted and bent
  - Sideloads of crank and pin
  - When tested, erratic operation

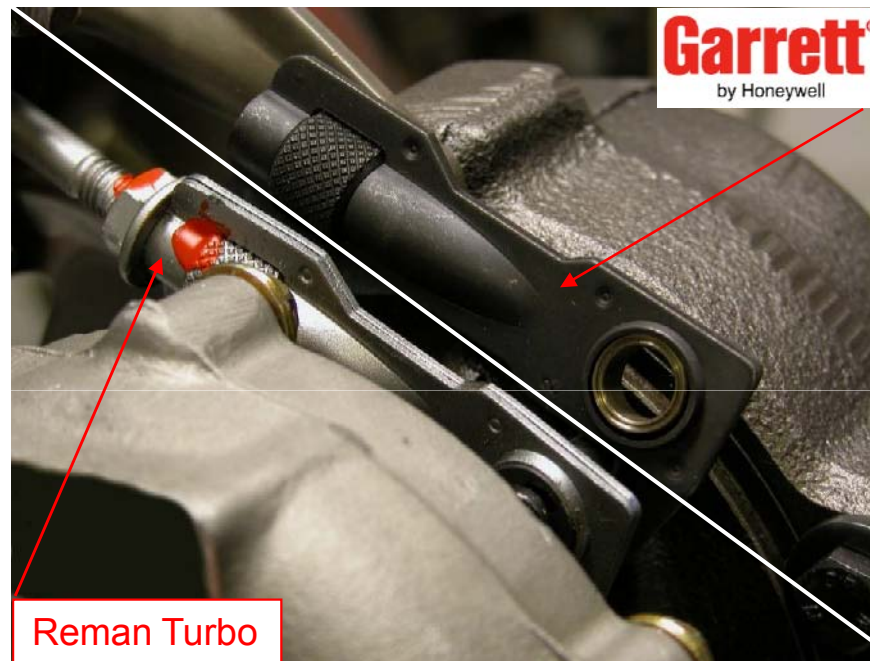
- Surface finish removed during cleaning process
  - May rapidly corrode and restrict movement.
- Corrosion resistant Nitro-Carburised finish
  - Salt bath tested
  - Durability tested

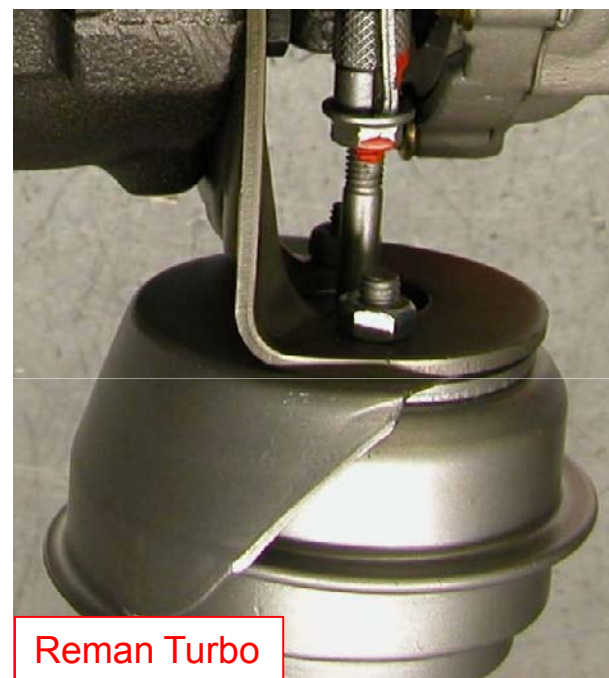
- No seal fitted
  - May allow water/dust ingress

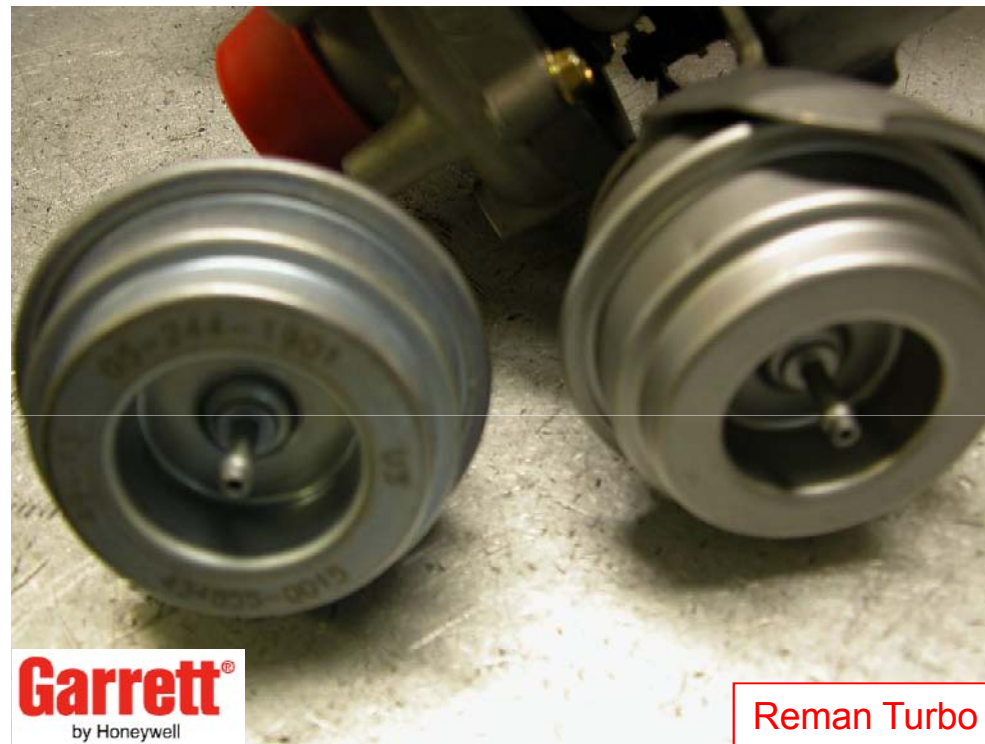
- Corrosion resistant finish
  - Salt bath tested
- Tested over 1,000,000 cycles
- Leak tested
- Surface finish removed during cleaning process
  - May corrode rapidly
- Testing unknown

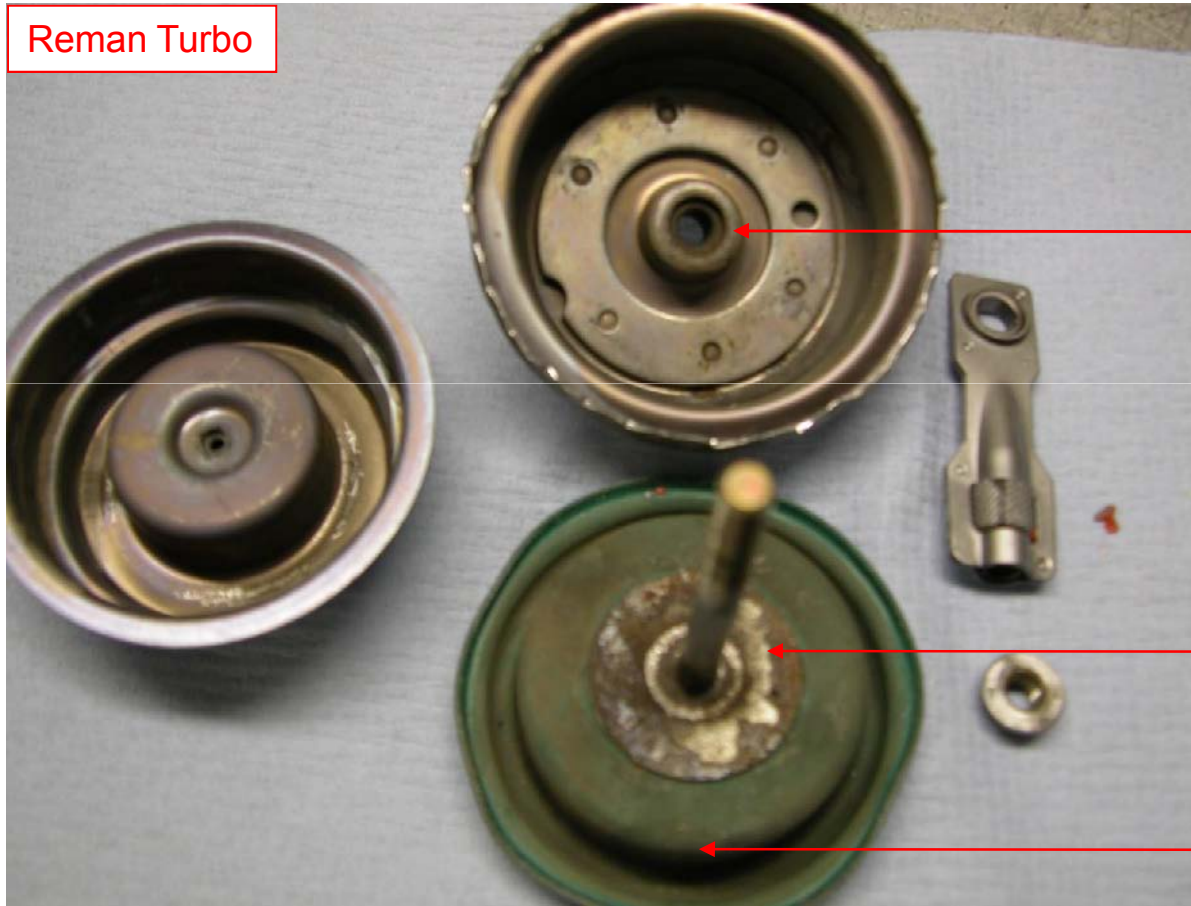
Reman Turbo

Worn gimble

Badly corroded piston components

Worn and damaged diaphragm

- Badly worn gimble
- Gimble is both linear bearing and seal
  - Poor control of actuator rod
  - Allows water/dirt ingress

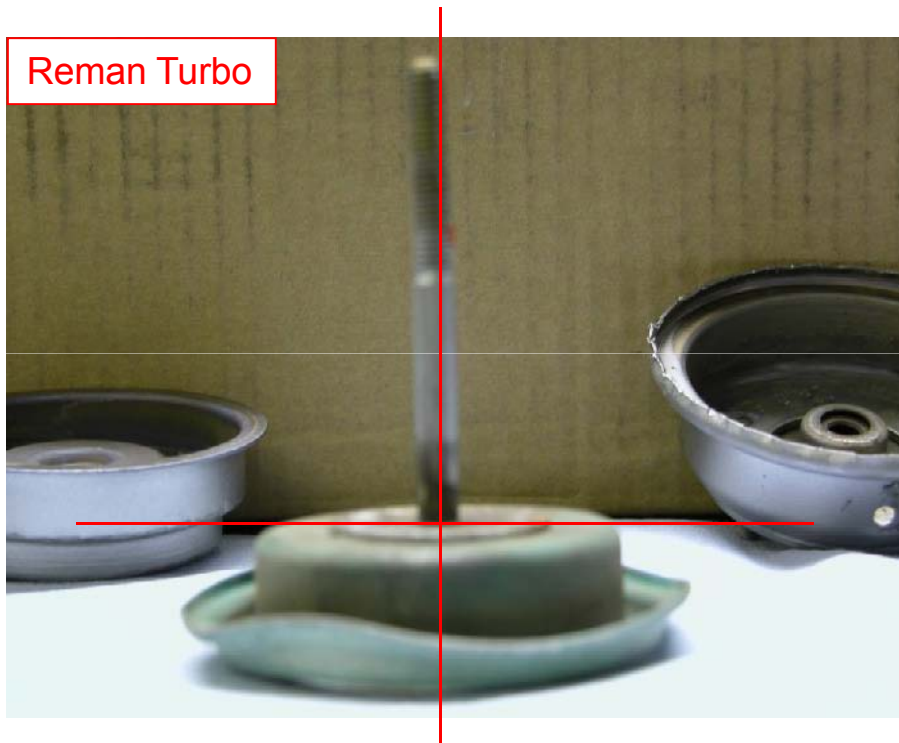
– Bent actuator rod

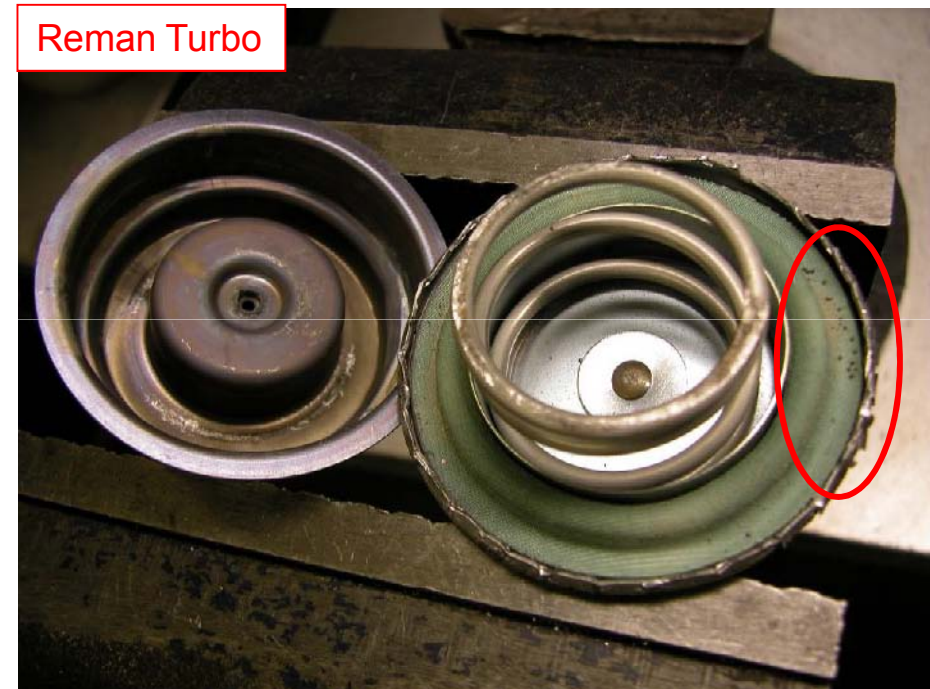
– Steel shot inside actuator

- Steel shot had entered actuator during reman cleaning process

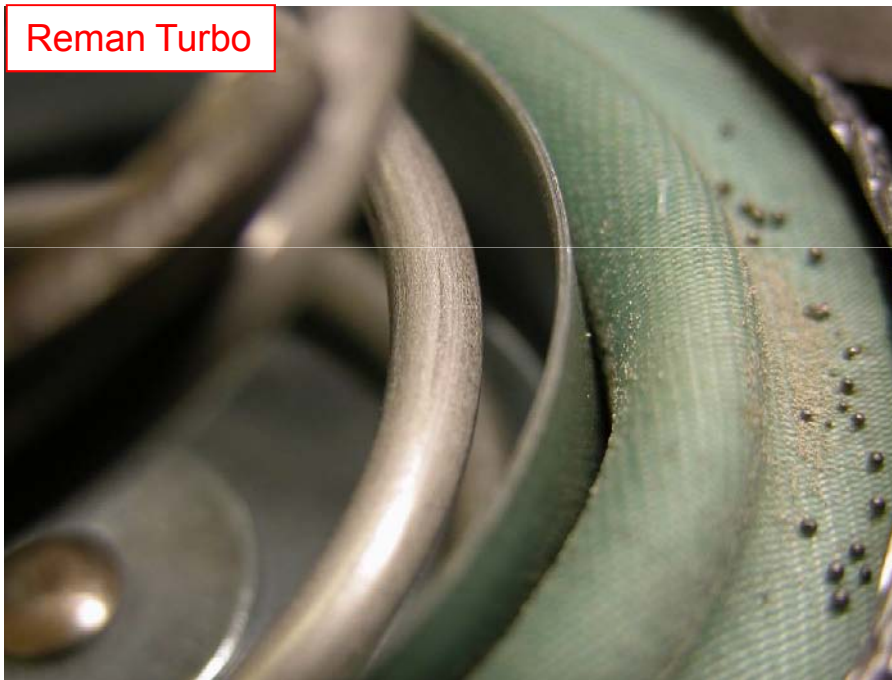
- Diaphragm reinforcing fibers worn
- Steel shot damage to diaphragm
  - Almost perforated

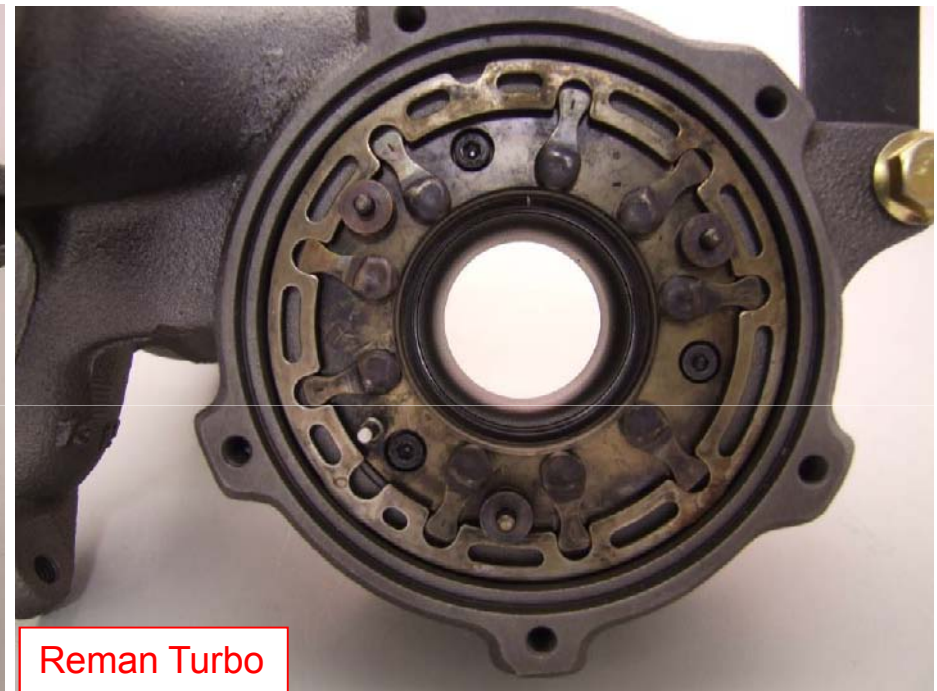
- Sticky and oily deposits on nozzle assembly and control mechanism
  - May burn on engine start up, carbon build-up may restrict movement

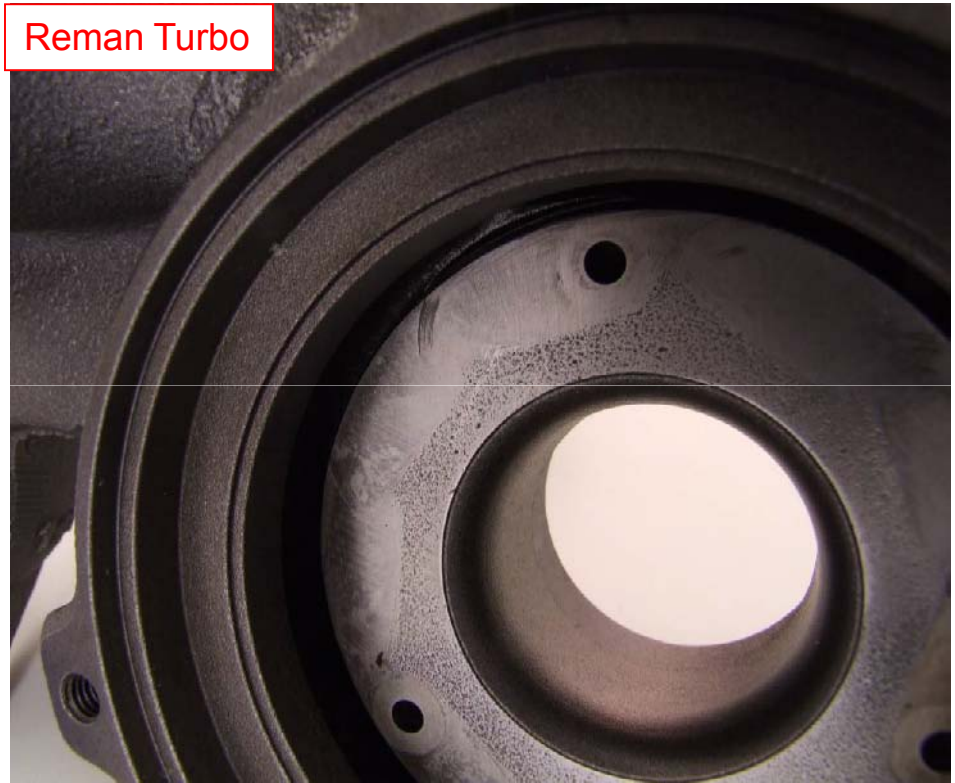
Reman Turbo

- Roughly machined face, uneven surface
- Poor surface finish
- No insert fitted

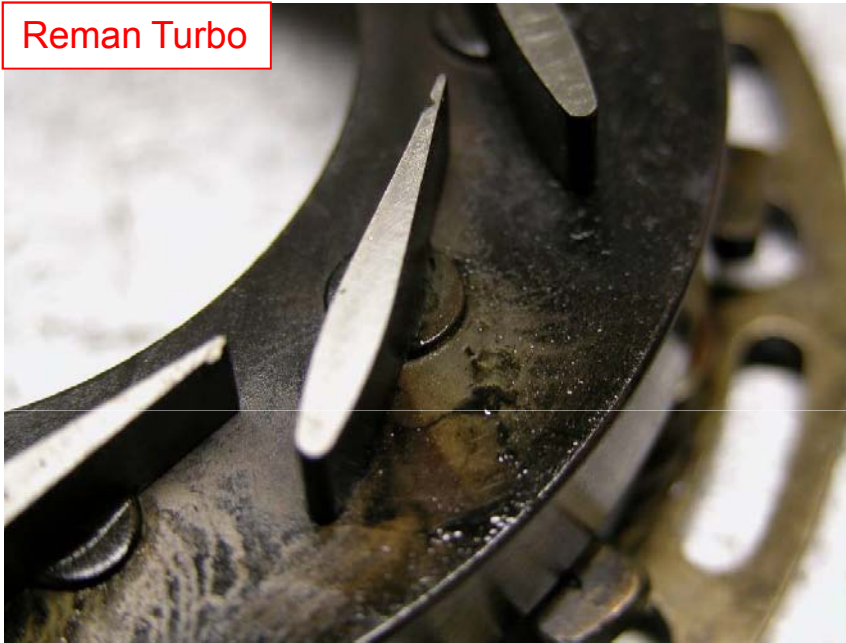
Reman Turbo

- Badly ground ends
  - Outside of tolerance
- 7 out of 9 vanes
  - Outside of tolerance
- Uneven dimensions
  - Outside of tolerance
- Tapered vane faces from leading edge to trailing edge
  - Outside of tolerance

- Restricted movement of nozzle assembly may cause permanent contamination of nozzle assembly, so reducing performance.
- Impact on low rpm efficiency of the turbine, with a reduction in engine performance at low speed.

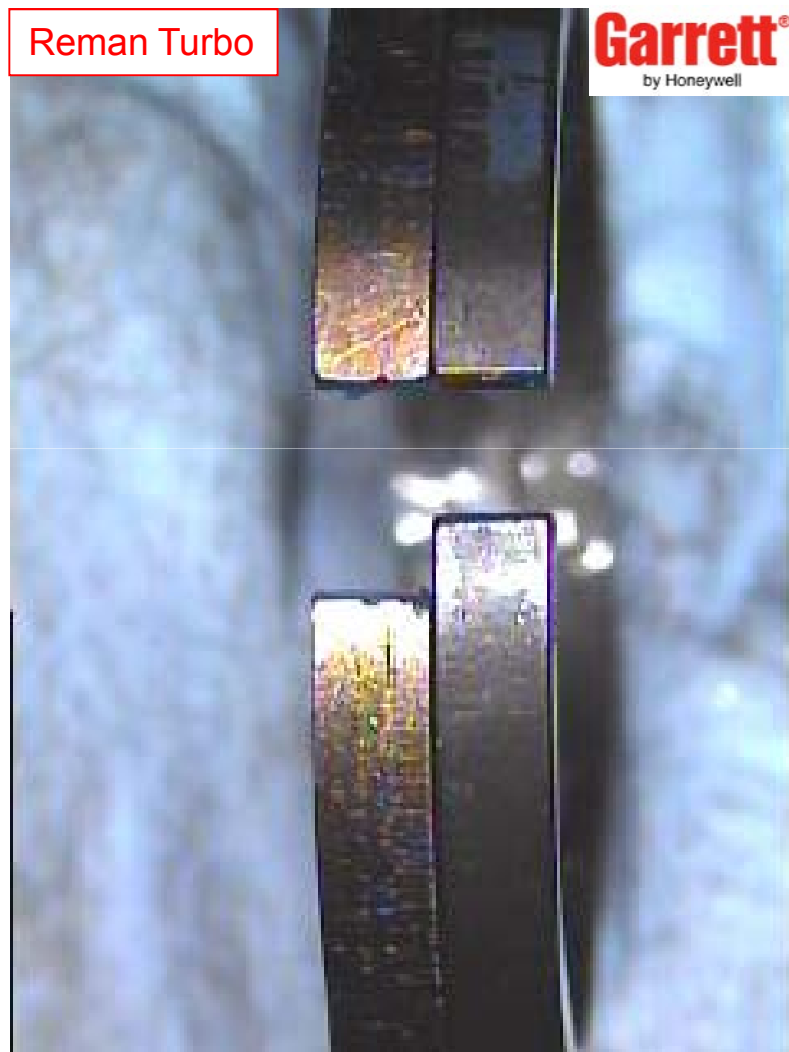
- Piston ring is gas/oil seal
- Reman turbo contains piston ring with incorrect end gap
  - Outside of specification
- Unknown material

- Dependent on running conditions:
  - Increased gas leakage into center housing
    - Increased oil drain/crankcase pressure
  - Increased oil leakage into turbine housing
- Possible risk from wrong material
  - Distortion/buckling of ring
  - Contact with rotating assembly

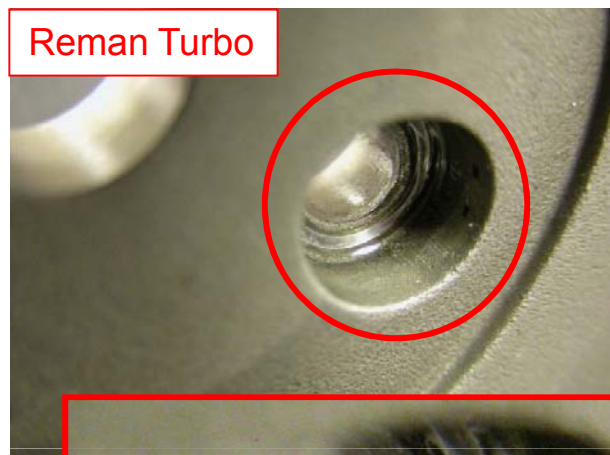
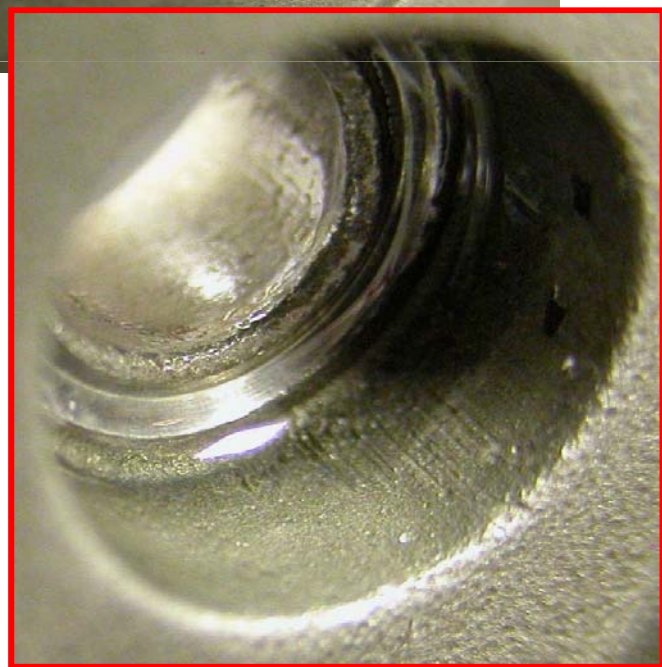
- Retaining bolts overtightened

- Oil sealing area damaged

- Oil leakage from center housing into compressor
- Oil contamination of air pressure hoses and intercooler
- Oil burned during combustion process
- Emissions out of specification

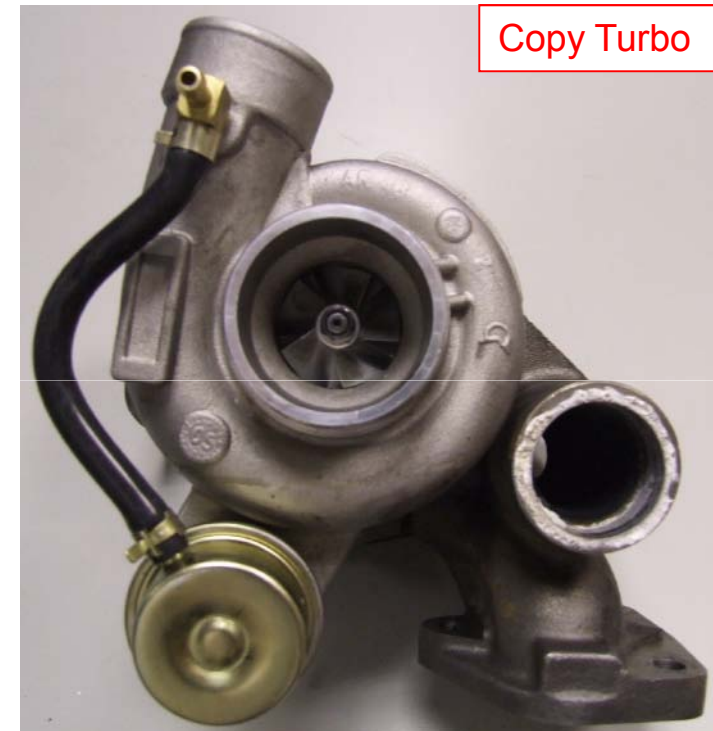
- Results
  - Specification = 1.240 – 1.309 Bar = 0.380mm of rod end movement
  - Actual result averaged over three tests = 1.130Bar = 0.380mm of rod end movement
- Conclusion
  - Calibration outside of specification
  - Possible effects:
    - Poor performance
    - Increased emissions
    - Reduced airflow to engine = fuel rich mixture = excessive combustion temperature = excess thermal loading on engine components, possible damage to turbine side of turbocharger and engine damage

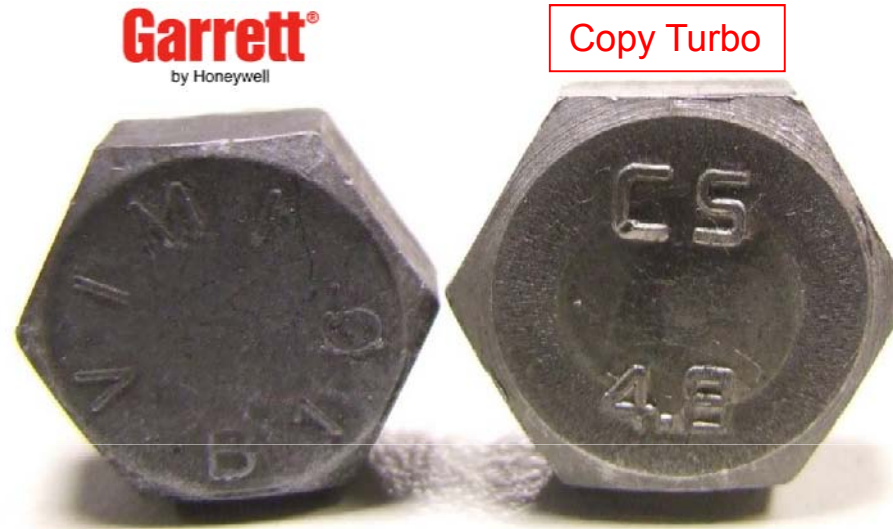
- Garrett uses B16 High temperature bolts for elevated temperatures (540°C at joint) - Tensile Strength  $\geq 1000$  Mpa
- Chromium, Molybdenum, Vanadium
- Copy uses 4.8 grade low temperature bolts approx (300°C) - Tensile Strength  $\geq 340$  Mpa
- Low or medium carbon steel, fully or partially annealed

***Very high risk of bolts “relaxing” and center housing to turbine housing joint loosening***

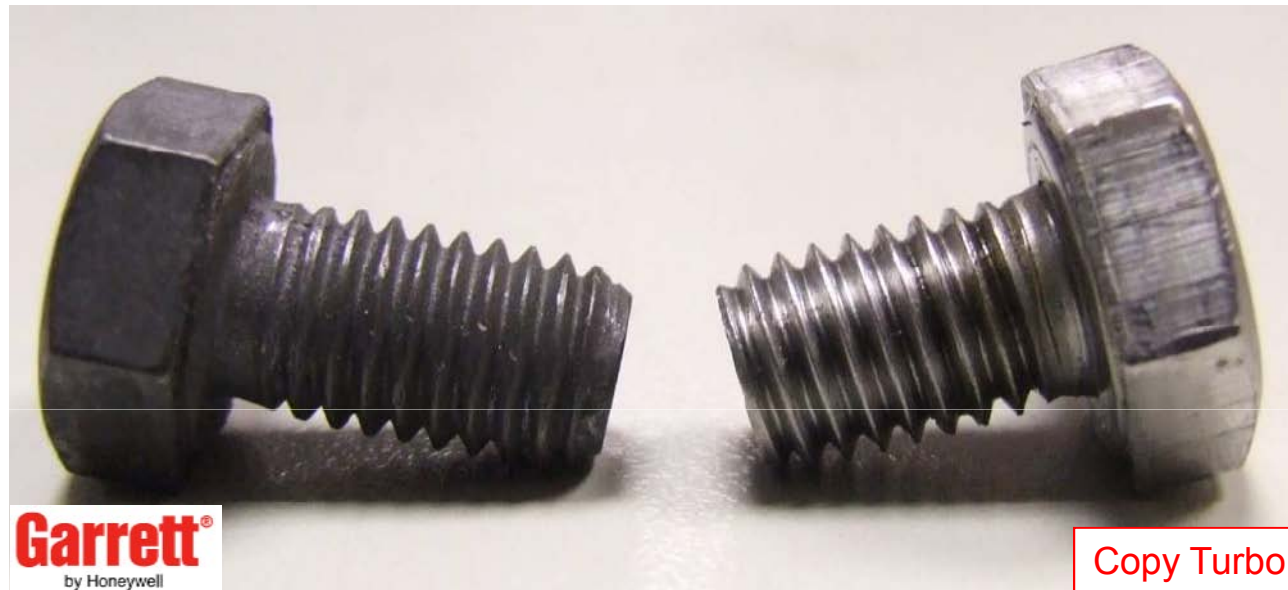
- Garrett B16 turbine bolts are pre-coated with low friction compound to ensure that tightening torque is not overcoming thread friction
- Copy bolt has no coating

***Part of tightening torque lost due to thread friction.  
High risk of gas leakage and joint loosening***

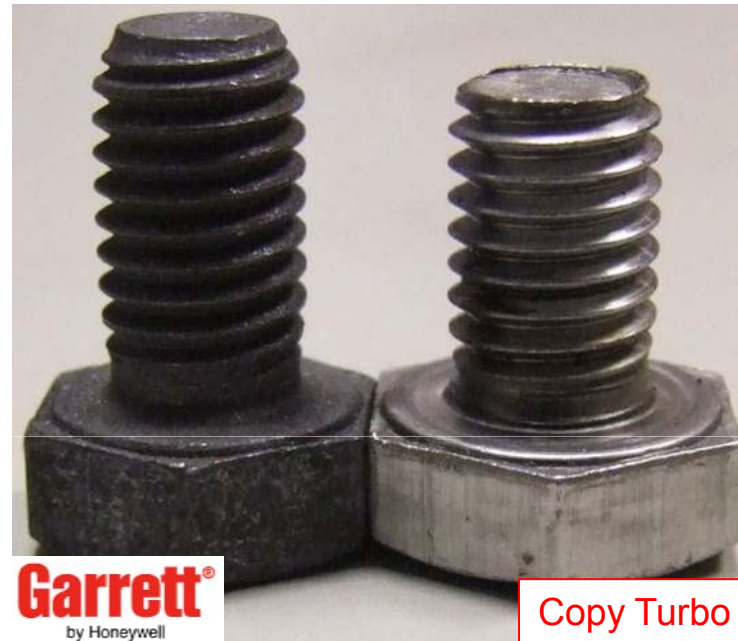
- Garrett bolt is **14 mm long** to give correct clamping force to critical joint and correct load distribution across full thread helix
- Copy bolt is **12 mm long**

***Very high risk of center housing and turbine housing joint loosening***

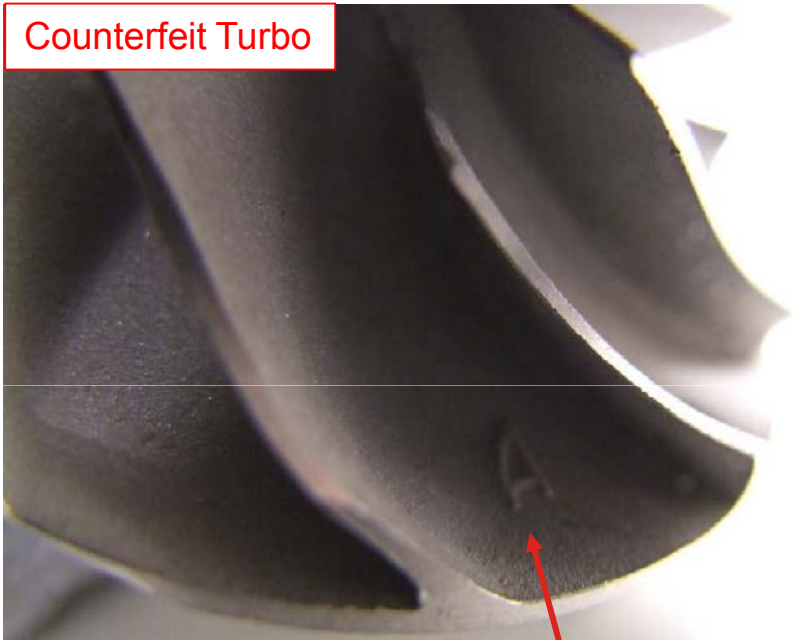
Counterfeit Turbo

Wheel uses Honeywell's registered trademark "A" originating from Garrett AiResearch, which makes this a counterfeit

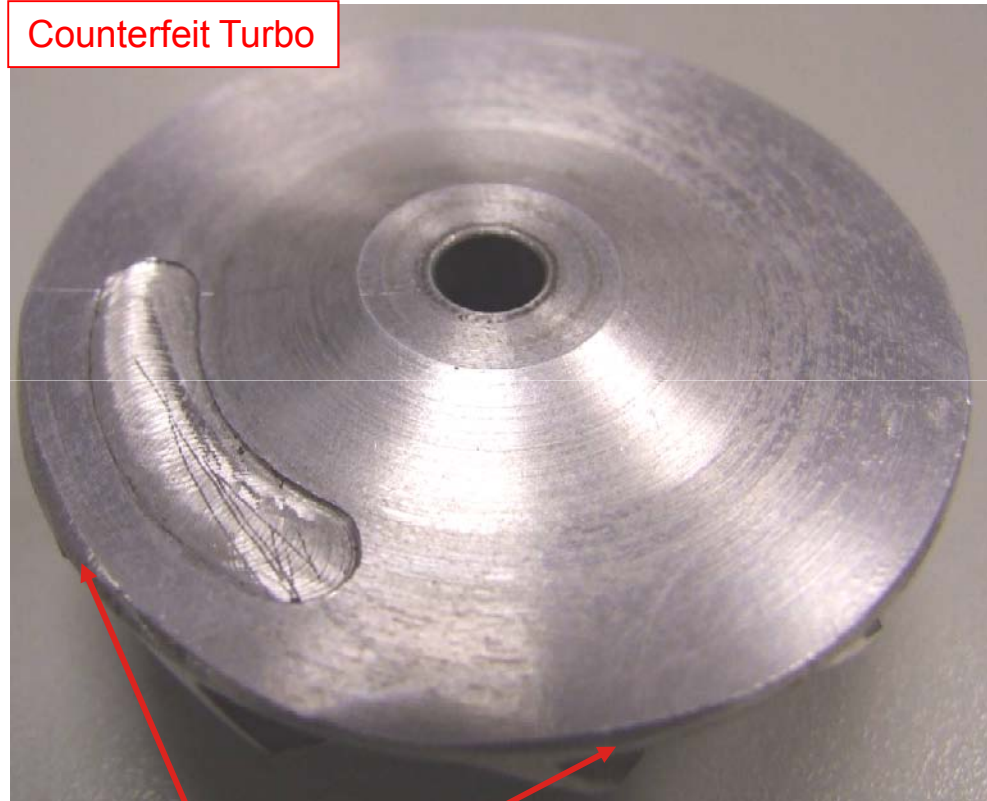
Counterfeit Turbo

Machined edge appears to be roughly hand finished

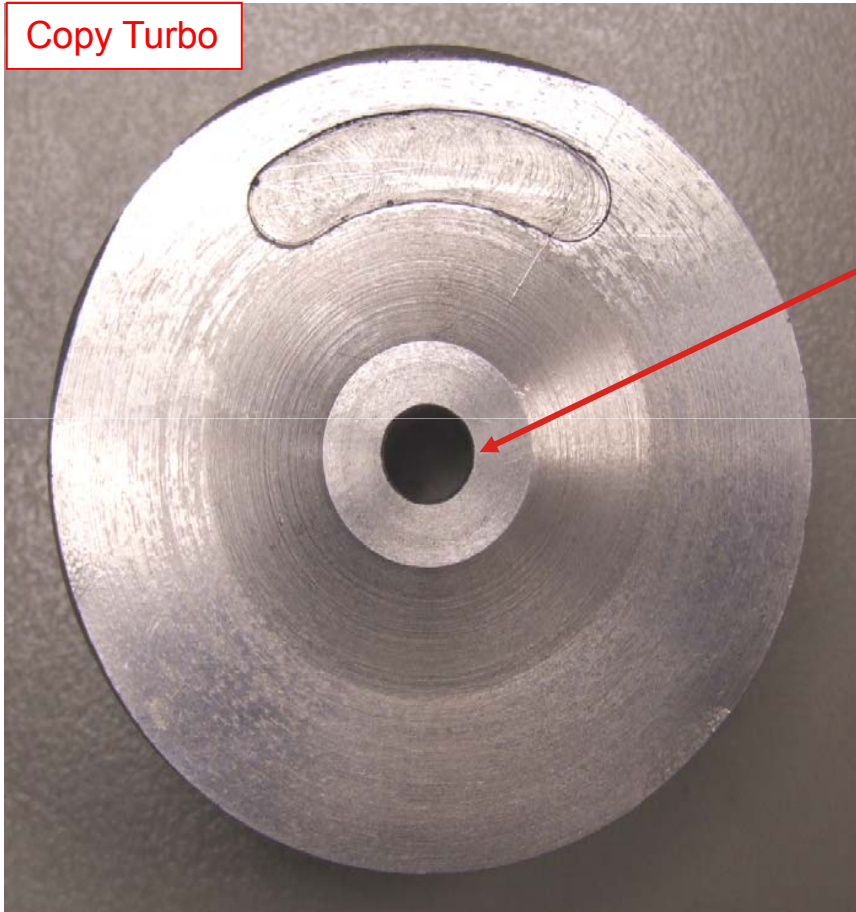
Copy Turbo

Oversized compressor wheel bore by 0.016mm over top limit and 0.024mm over bottom limit

The clearance between this compressor wheel and its pilot shaft could be easily detected by hand, without even needing measuring instruments!

***Implications for wheel location, balance, noise and reliability***

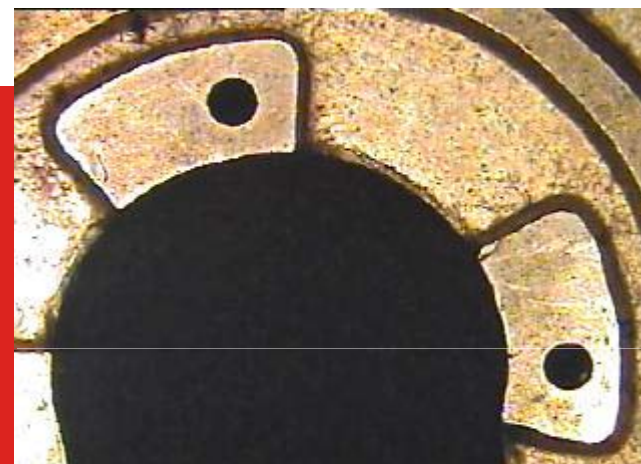
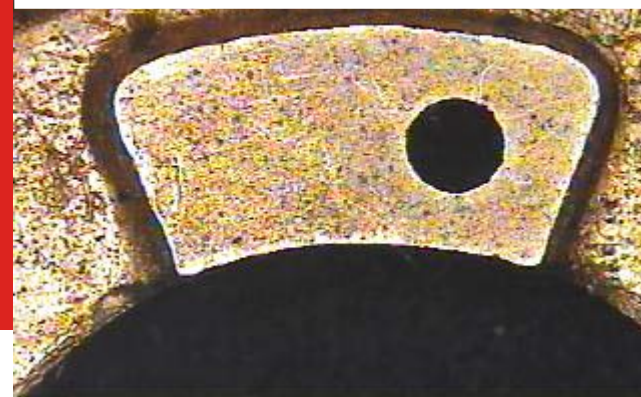
Copy Turbo

Incorrect oil feed hole positions

PCD of holes outside of specification

Flatness of critical  
"A" face

almost double Garrett  
tolerance!

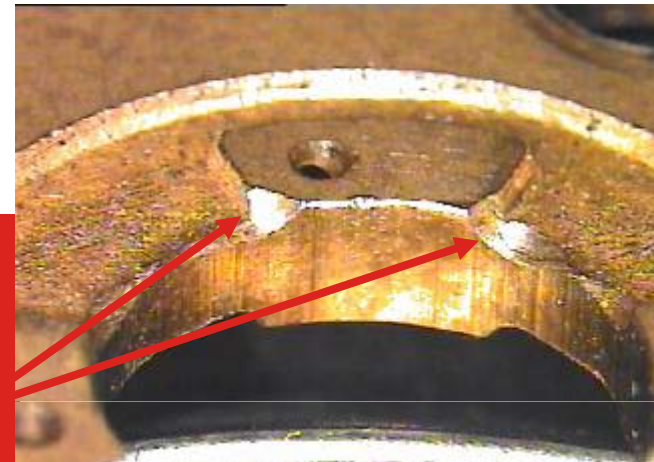
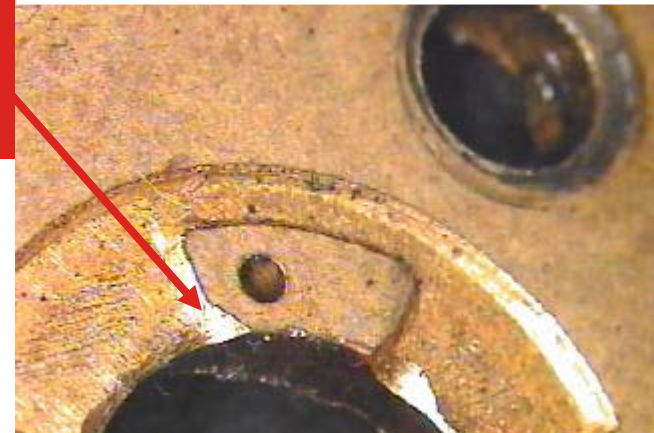
Copy Turbo

Poor finishing of thrust pads on copy reduces thrust pad area and weakens bearing

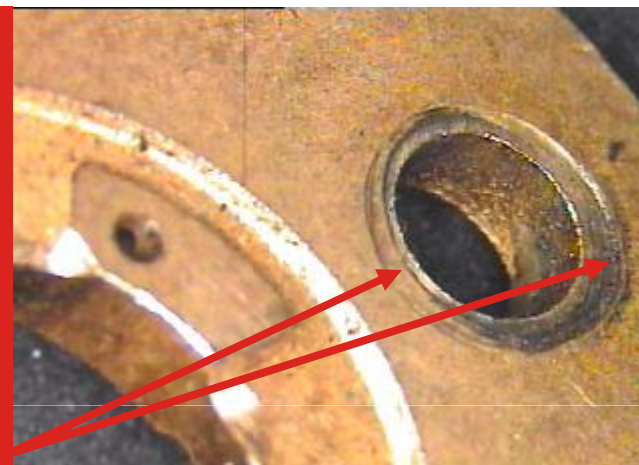
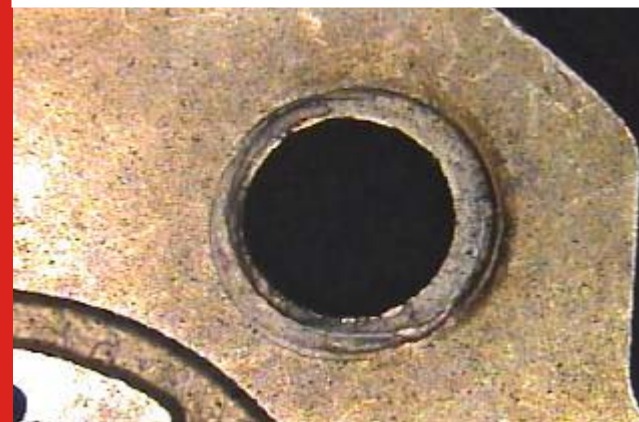
Copy Turbo

Copy bearing already distorted:

Flatness is almost double correct specification (distortion)

Witness marks show how the (incorrect specification) bolts have bitten into the surface of the bearing unevenly

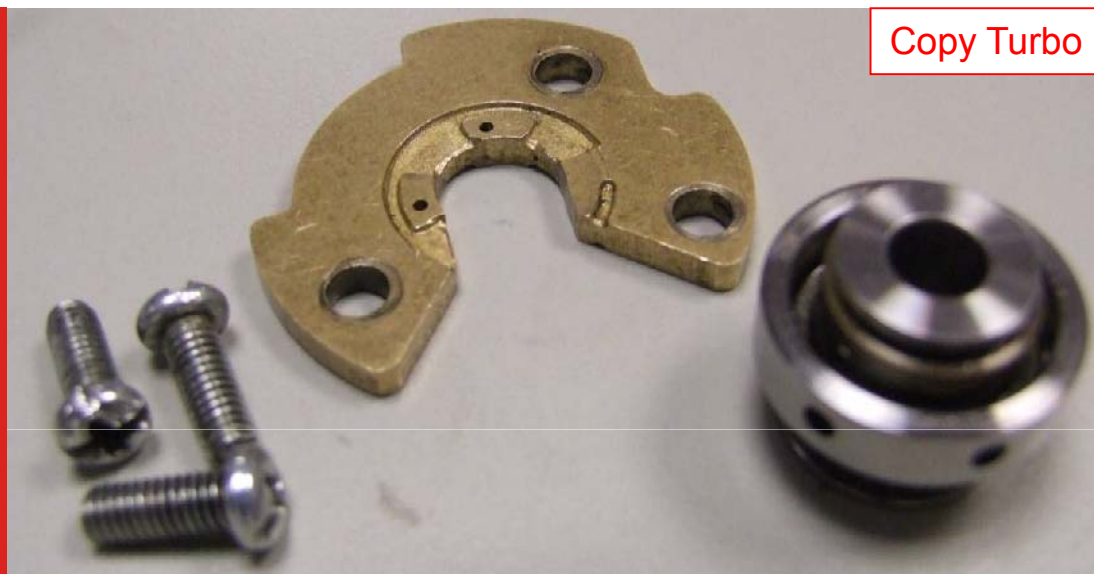
Material to be confirmed, but appears to be low quality, non high tensile bolts.

Uneven marking around bolt holes is consistent with poor surface flatness results

***Bolts not to Honeywell specifications***

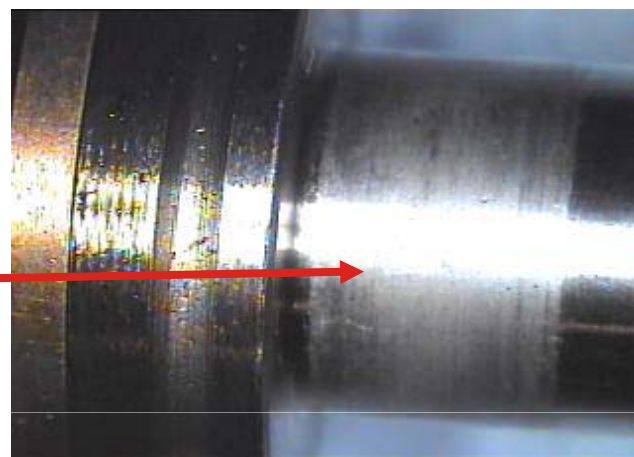
Turbine  
end  
journal  
scored

- Heavily loaded bearings due to component imbalance

***Serious damage for a turbo which has only run briefly!***

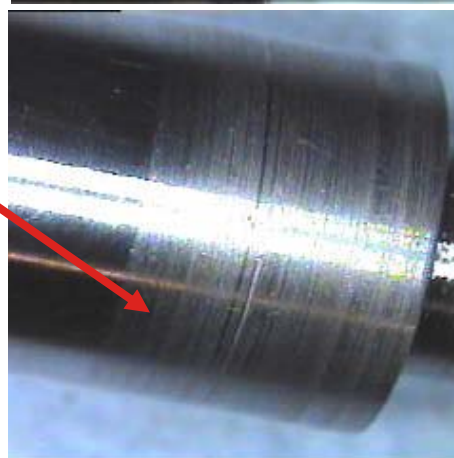
Compressor  
end journal  
scored

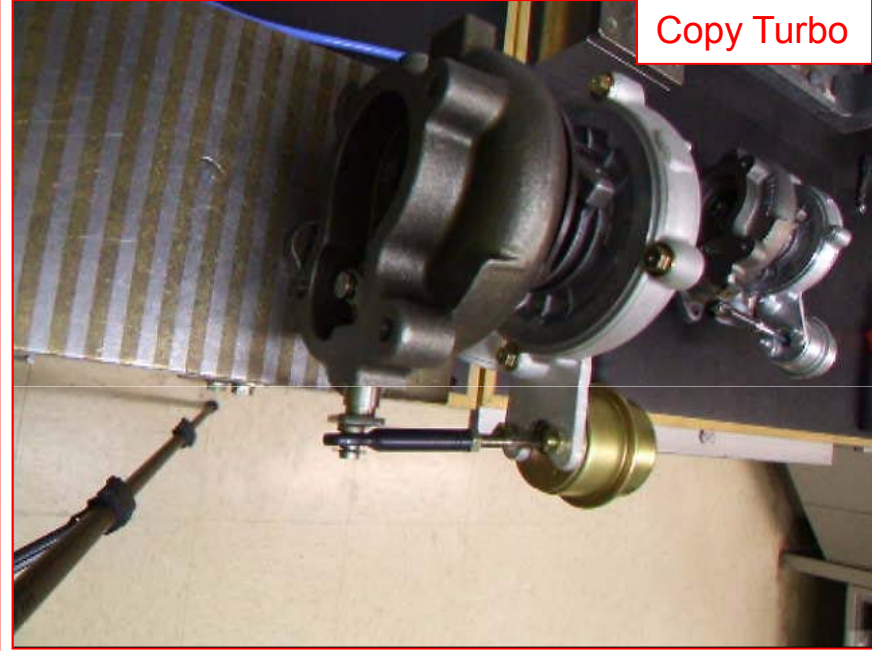
Copy Turbo

- Erractic motion
  - High wear rate to rod end/crank pin
  - Wastegate control deteriorate rapidly

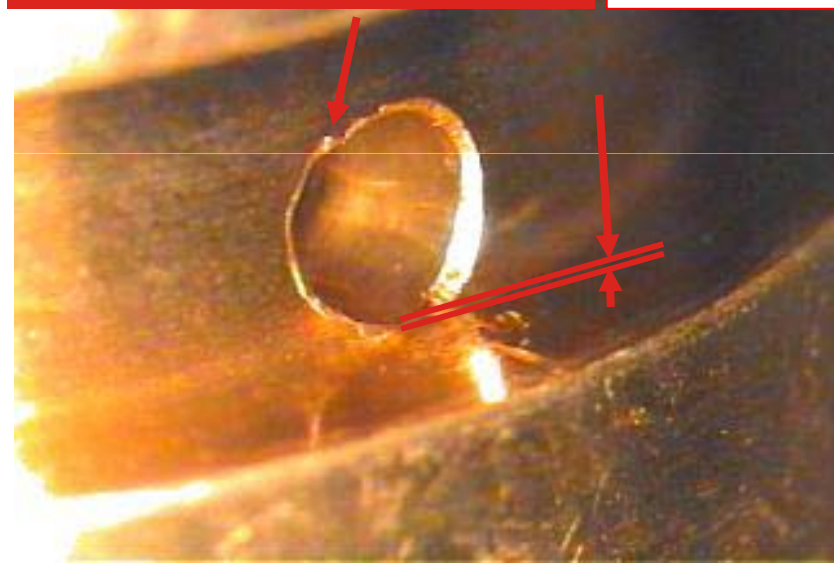
Copy Turbo

- Oil supply holes to journal bearings
  - Incorrect location
  - Poor finish: Hanging burrs – material will break away due to normal vibration

Poor de-burring, rough edges

Incorrect oil hole position
